## Uniformity in pressurized irrigation systems depends on design, installation

Gordon E. Little a David J. Hills a Blaine R. Hanson

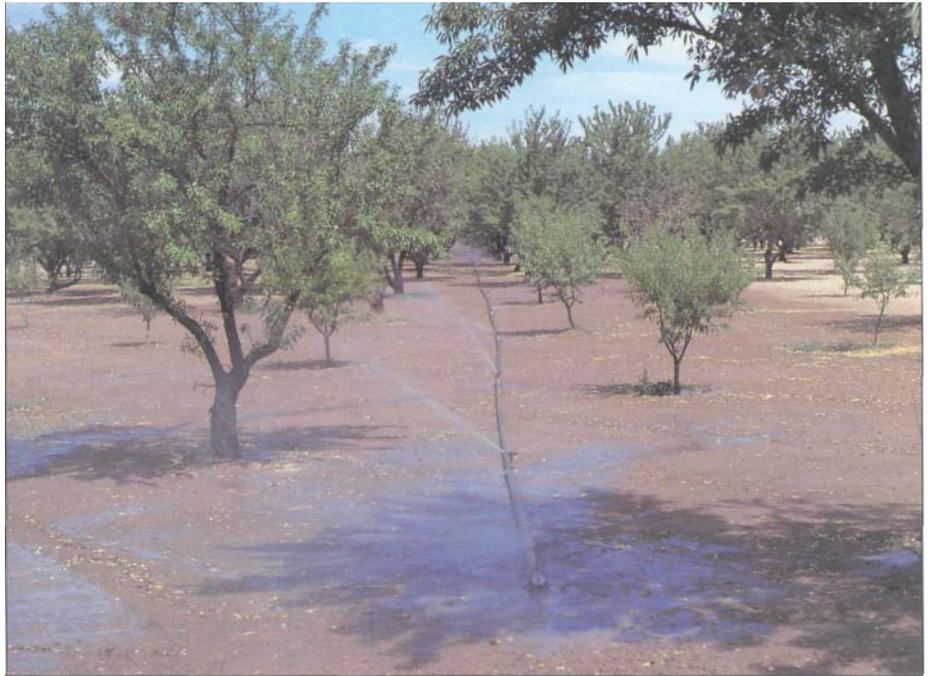
Almond orchard being irrigated with sprinklers.
